Re: **LEVEL I: FULL RESERVE STUDY**
STEEPLE RUN COMMUNITY COUNCIL
Naperville, Illinois
LM Project No. 120.294

LEVEL I: FULL RESERVE STUDY

PROPERTY NAME: Steeple Run Community Council

LM PROJECT No.: 120.294

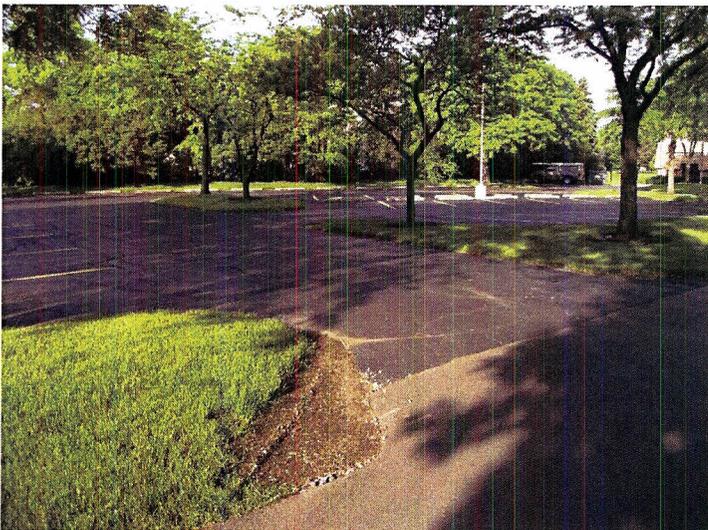
| No. | Item | Quantity | Units | Unit Cost | Immediate Cost |
|---|--|---|---|---|---|
| 1.0 | Asphalt Pavement: The asphalt pavement is generally in fair to poor condition. The surface was recently resealed and restriped; however, cracks were not sealed and areas of pavement settlement were not replaced (see Photon Nos. 2, 4-7, and 37). We provide an allowance for replacement of approximately 10% of the pavement area. | 3,000 | sf | \$1.50 | \$4,500.00 |

2. General view of the parking area, noting that the pavement was recently resealed and restriped.

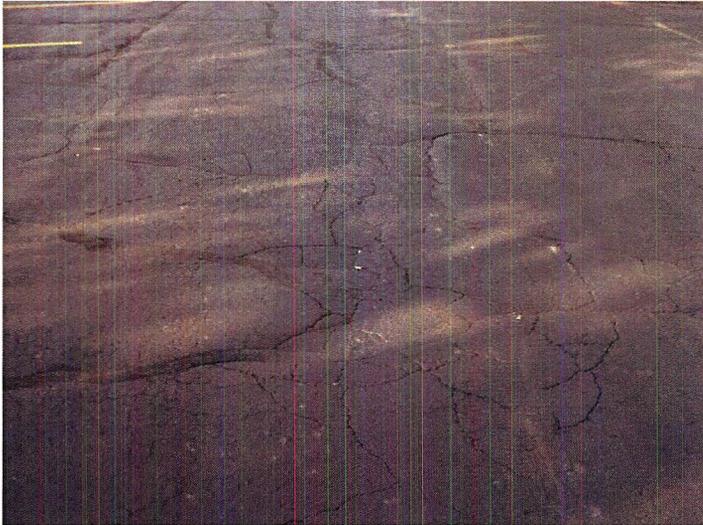
4. View of the general condition of the asphalt pavement.

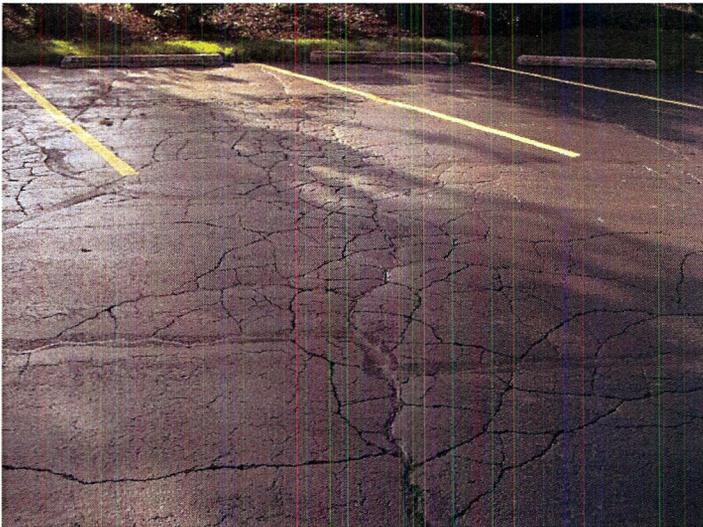
5. View of asphalt pavement settlement and deterioration.

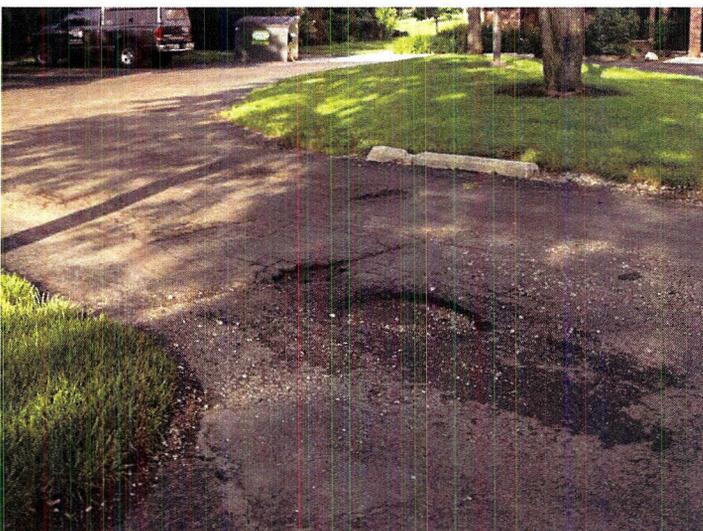
6. View of potholes in the asphalt pavement.

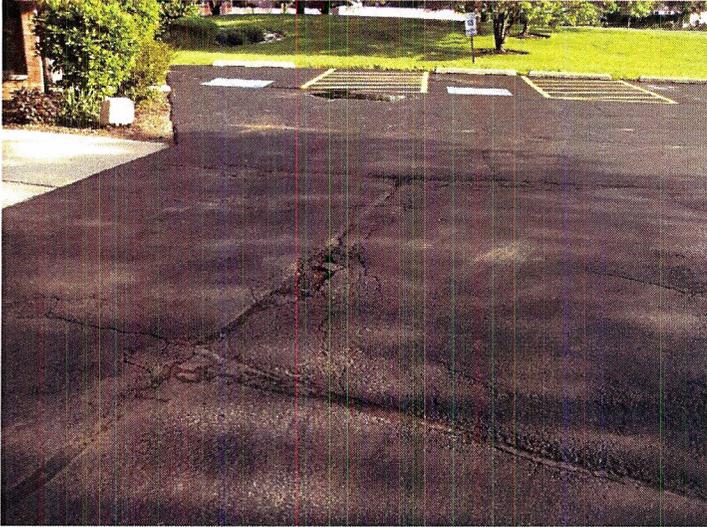
7. View of asphalt deterioration in front of the entrance to the clubhouse.

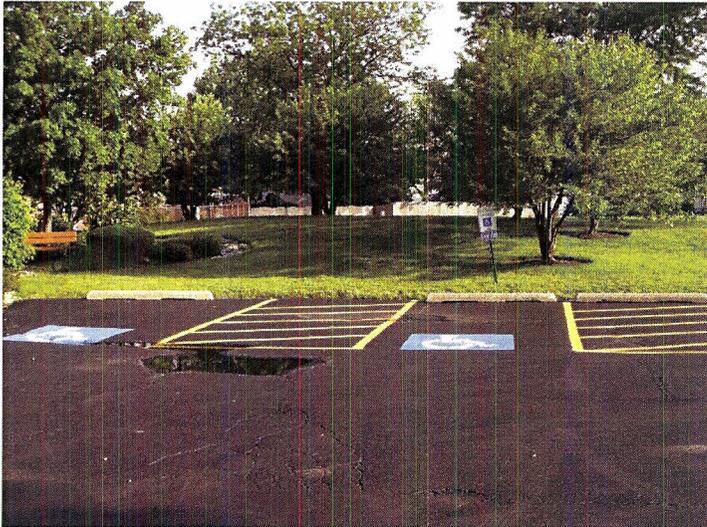
| No. | Item | Quantity | Units | Unit Cost | Immediate Cost |
|--|--|---|---|---|---|
| 3.0 | Two of the surface parking spaces are reserved for persons with disabilities; however, signage has not been placed at the front of one of the spaces (see Photo No. 8). We recommend that the signage be installed in accordance with ANSI A117.1. | 1 | ea | \$200.00 | \$200.00 |

8. View of parking spaces designated for use by persons with disabilities. Note that one parking space is not provided with proper signage.

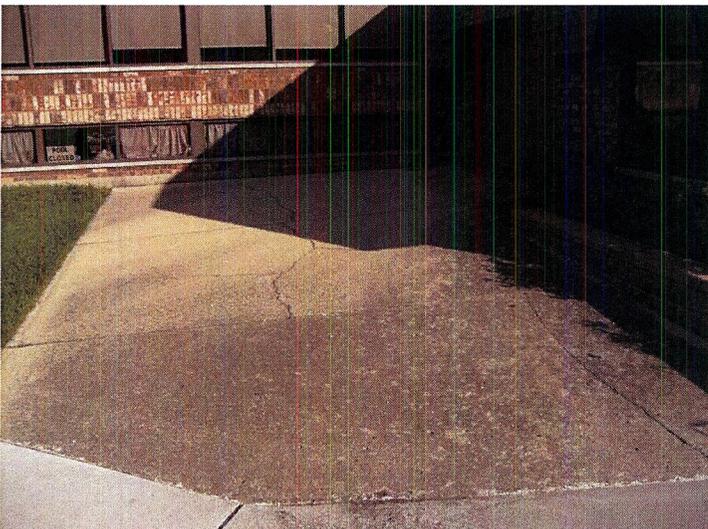
| No. | Item | Quantity | Units | Unit Cost | Immediate Cost |
|---|--|---|---|---|---|
| 2.0 | Concrete Sidewalks: Minor cracking of the concrete sidewalks was noted at the approach to the maintenance room on the south side of the building (see Photo No. 12). We recommend that the cracks be sealed to prevent further deterioration of the concrete slab. | 1 | ls | \$200.00 | \$200.00 |

12. View of minor cracking of the concrete pavements leading to the maintenance room.

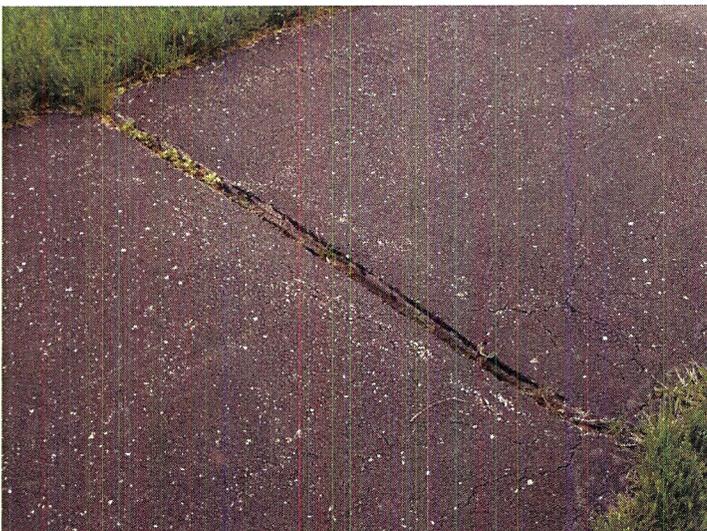
| No. | Item | Quantity | Units | Unit Cost | Immediate Cost |
|---|--|---|---|---|---|
| 3.0 | Asphalt Walking Path: The walking path generally appeared to be in good to fair condition; however, wide unsealed joints and cracking of the asphalt pavement were observed (see Photo Nos. 21, 22, and 25). Localized repairs appear to be necessary. | 8,500 | sf | \$0.10 | \$850.00 |

21. View of an open joint in the walkway path.

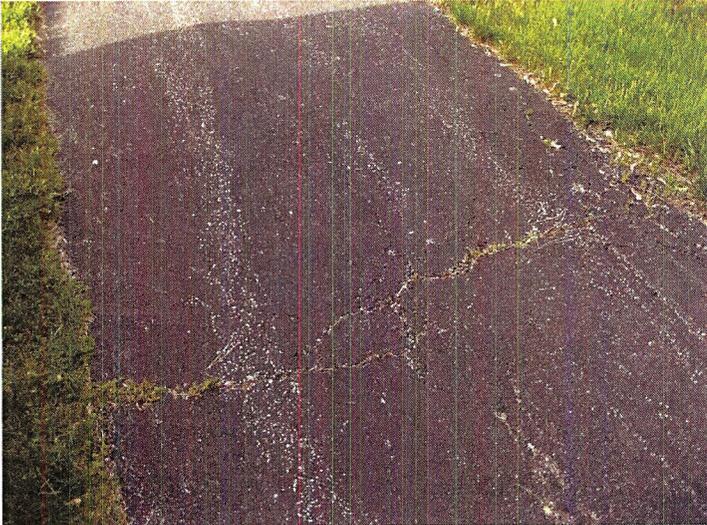
22. View of cracking noted in the walking path.

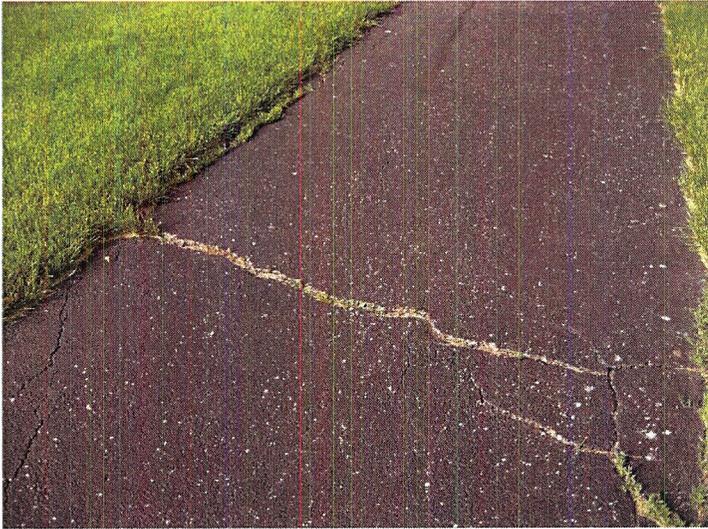
25. View of cracking in the walking path.

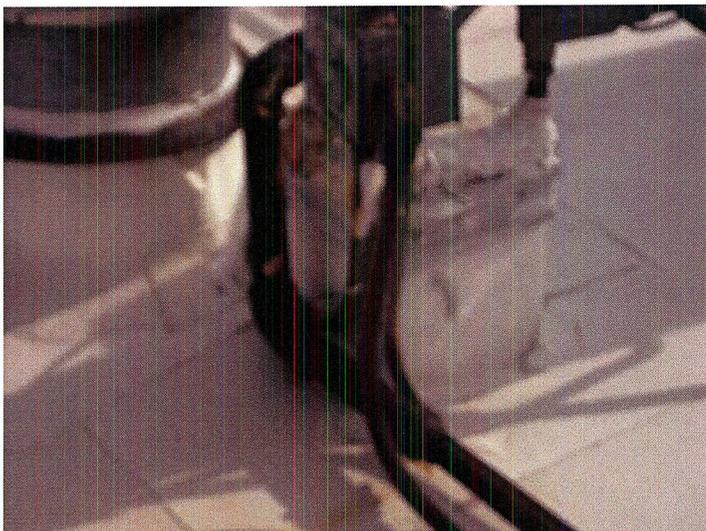
33. View of surface corrosion at the gas pipe and conduit lines on the roof.

| No. | Item | Quantity | Units | Unit Cost | Immediate Cost |
|---|---|---|---|---|---|
| 10.2 | We recommend that the electrical conduit and gas piping be cleaned of all rust and scale, then coated with a rust inhibitive paint. | 1 | ls | \$200.00 | \$200.00 |

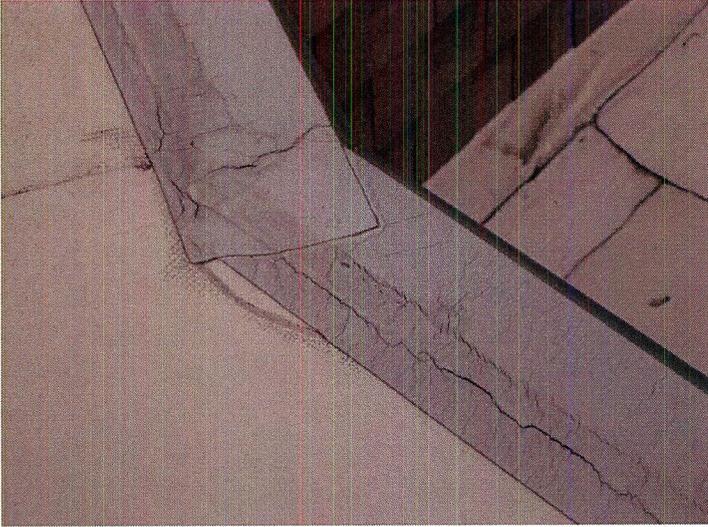
| No. | Item | Quantity | Units | Unit Cost | Immediate Cost |
|---|---|---|---|---|---|
| 10.0 | Roofing: The roofing assemblies generally appeared to be in fair condition; however, we observed extensive deterioration of the perimeter edge flashing membrane (see Photo Nos. 34 and 36), open gutter seams (see Photo No. 35), and surface corrosion on the electrical conduit and gas piping on the low-slope roof areas (see Photo Nos. 32 and 33). Evidence of roof leaks were also observed throughout the building (see Photo Nos. 41 and 49). Shingles on the mansard roof areas appeared to be in acceptable condition; loose or damaged shingles were not observed. We, therefore, recommend immediate replacement of the low-slope roofing assembly to prevent further potential deterioration of the structural roof elements. See the <i>Replacement Reserve Schedule</i> for anticipated shingle roofing replacement. | | | | |

34. View of aging typically noted at the perimeter flashing membrane.

| No. | Item | Quantity | Units | Unit Cost | Immediate Cost |
|---|---|---|---|---|---|
| 10.1 | Low-slope roofing replacement. | 4,000 | sf | \$5.50 | \$22,000.00 |

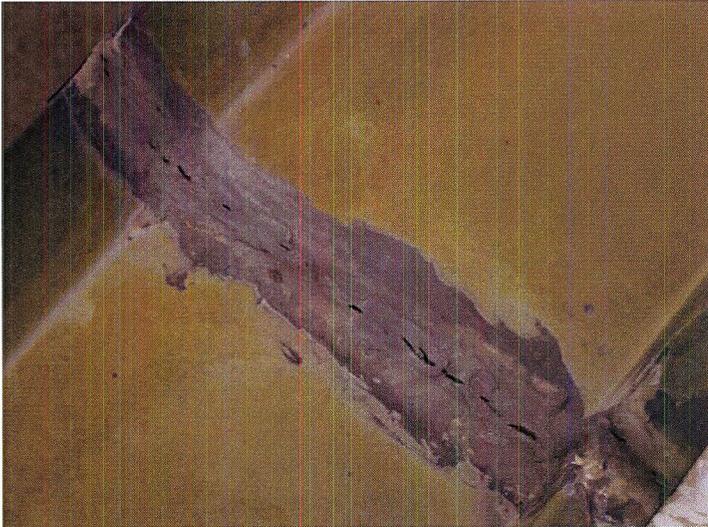
35. View of an open seam at the gutter area of the high roof east end.

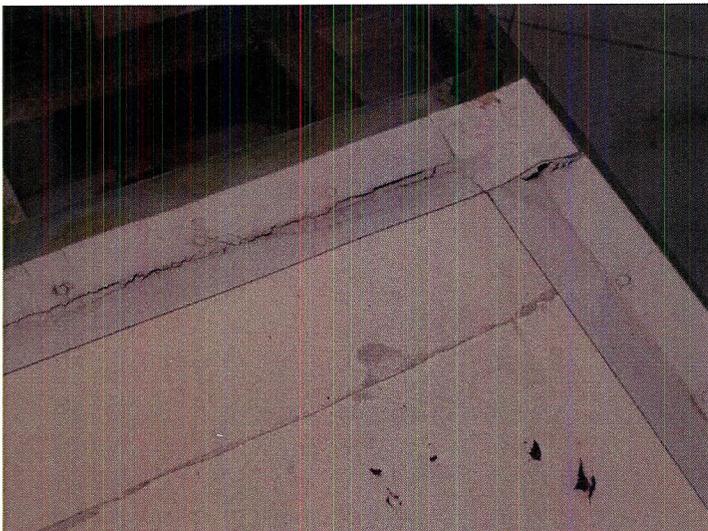
36. View of deteriorated and split flashing membrane at the southeast corner of the low south roof area.

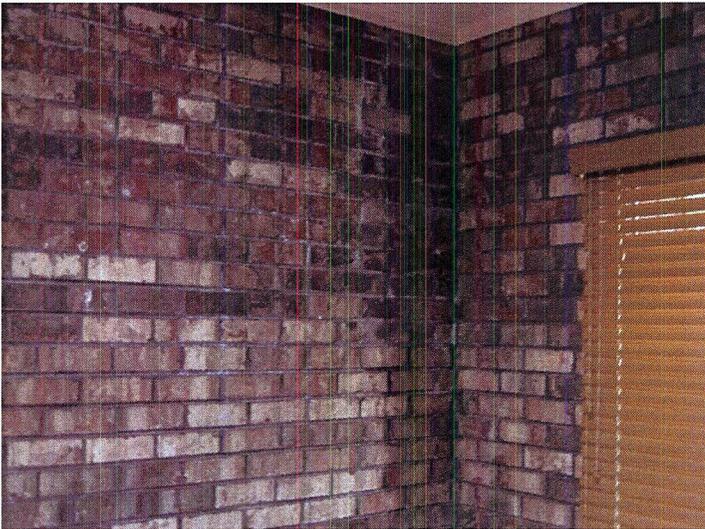
41. View of evidence of water penetration at the southeast corner, below the south low roof area.

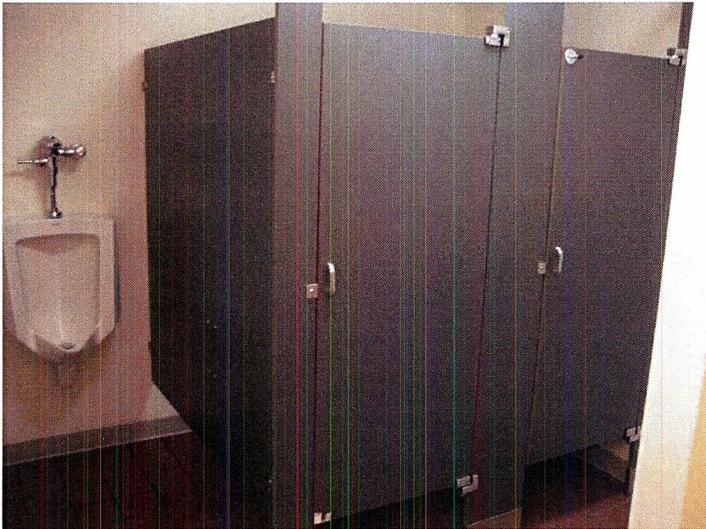
44. View of the men's restroom in the upper lobby area, noting that the space is not designed for access by persons with disabilities.

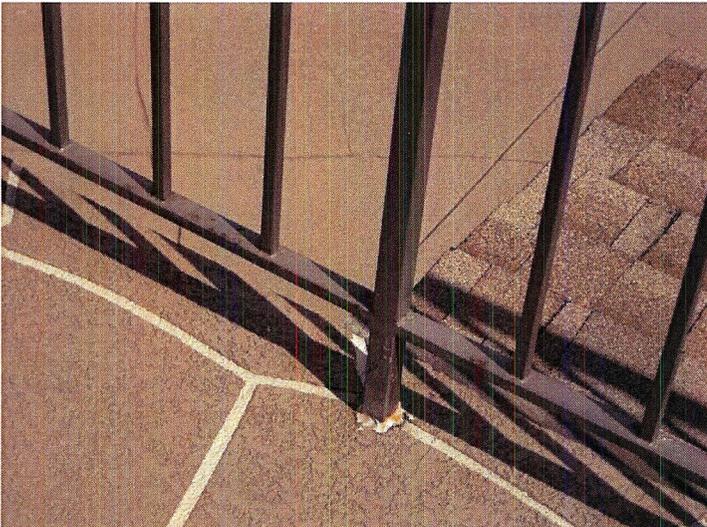
| No. | Item | Quantity | Units | Unit Cost | Immediate Cost |
|---|--|---|---|---|---|
| 5.0 | Pool Area Fencing and Exposed Metals: The pool area fencing appeared to be in serviceable condition (see Photo No. 15); however, surface corrosion was observed on the shade structures and elevated deck guard rails (see Photo Nos. 47 and 67). We recommend that the exposed metal surfaces at the shade structures and elevated guardrails be cleaned of all rust and scale, then coated with a rust inhibitive paint. | 1 | ls | \$1,000.00 | \$1,000.00 |

47. View of minor surface corrosion noted at the guardrail at the elevated deck.

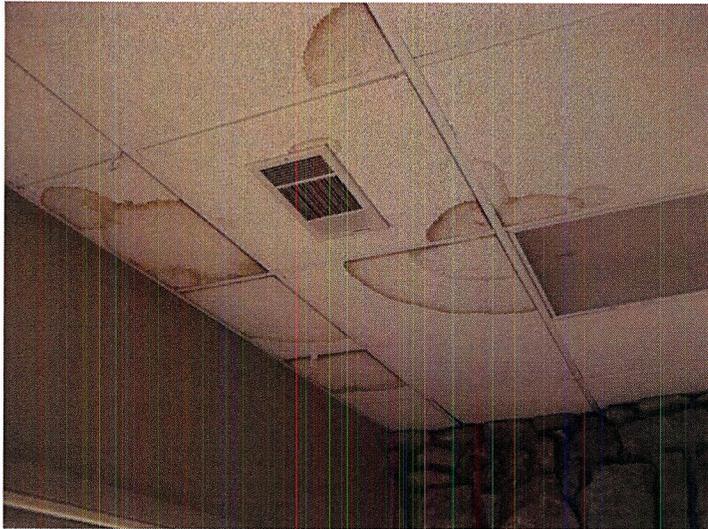
49. View of stained ceiling tiles at the south community room showing evidence of roof leaks.

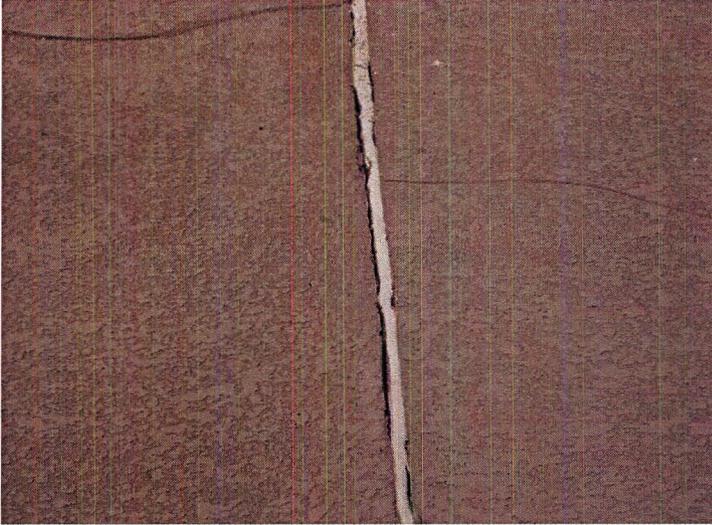
| No. | Item | Quantity | Units | Unit Cost | Immediate Cost |
|---|--|---|---|---|---|
| 4.0 | Swimming Pool: The swimming pool, surrounding deck, and elevated deck generally appeared to be in good condition; however, we observed failed joint sealant and localized cracking in the Sundek cementitious surfacing (see Photo Nos. 64, 66, 68, and 69). | | | | |

64. View of the typical failed sealant joints in the pool deck area.

| No. | Item | Quantity | Units | Unit Cost | Immediate Cost |
|---|--|---|---|---|---|
| | 4.1 We provide a budget to replace failed sealant joints. | 450 | lf | \$7.50 | \$3,375.00 |

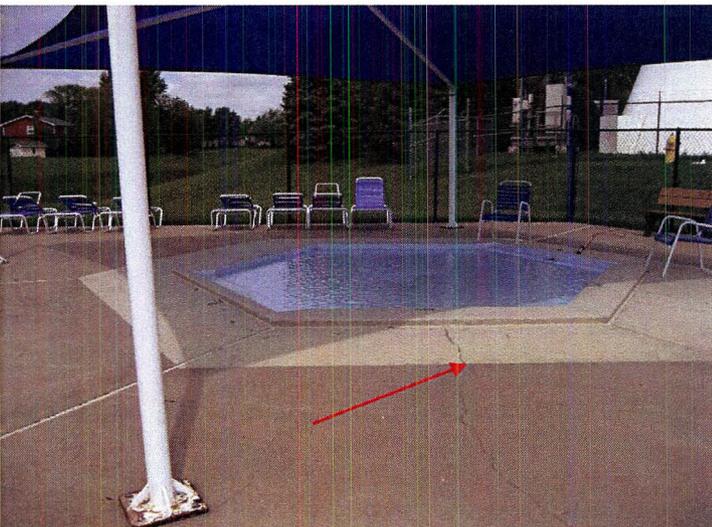
66. View of the hexagonal wading pool. Also note the cracking in the deck surfacing.

| No. | Item | Quantity | Units | Unit Cost | Immediate Cost |
|---|--|---|---|---|---|
| | 4.2 We provide an allowance to repair the Sundek surfacing cracks. | 1 | allow | \$5,000.00 | \$5,000.00 |

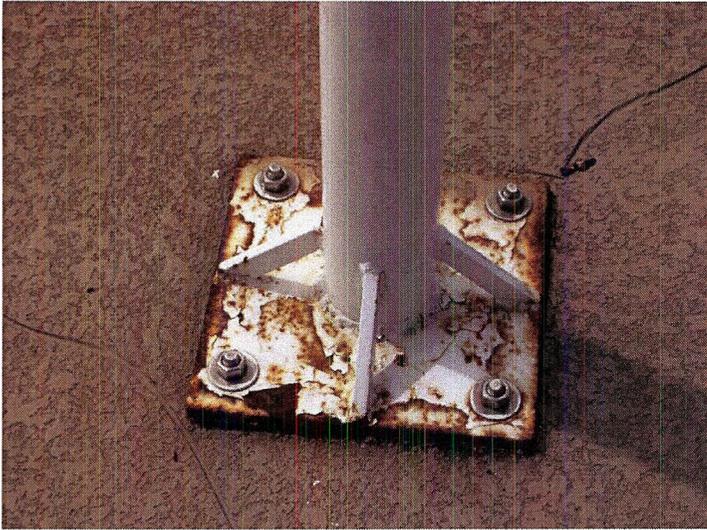
67. View of surface corrosion typically noted at the canopy supports in the swimming pool area.

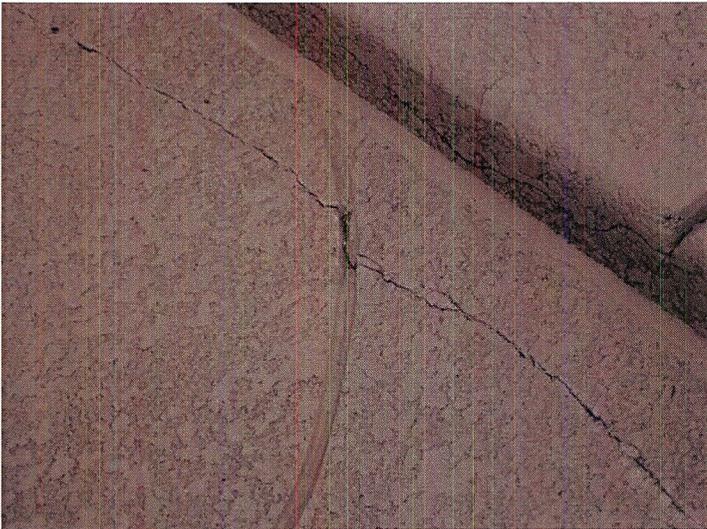
68. View of hairline cracking in the deck at the south end of the pool.

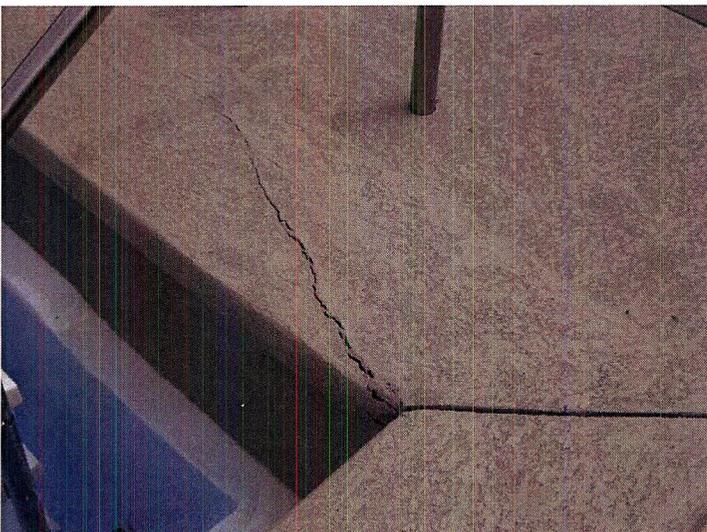
69. View of hairline cracking of the coping at the southeast corner of the pool.
