Re: **LEVEL I: FULL RESERVE STUDY**
STEEPLE RUN COMMUNITY COUNCIL
Naperville, Illinois
LM Project No. 120.294

LEVEL I: FULL RESERVE STUDY

PROPERTY NAME: Steeple Run Community Council

LM PROJECT No.: 120.294

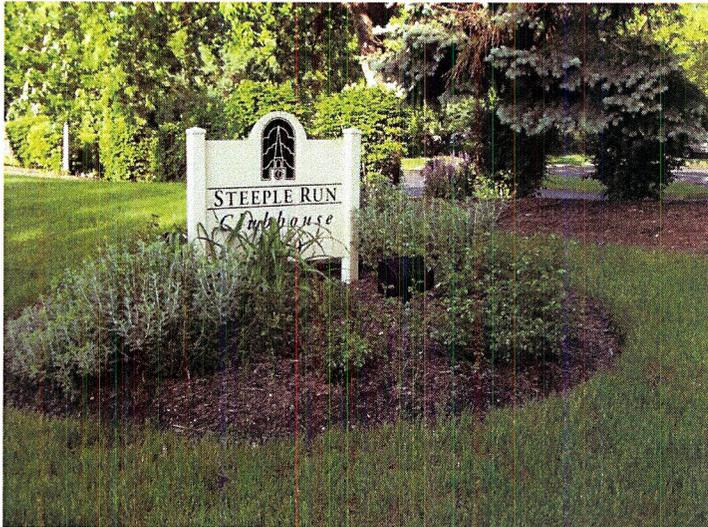
| No. | Item | Quantity | Units | Unit Cost | Immediate Cost |
|---|---|---|---|---|---|
| 8.0 | Property Signage: Property identification signage appeared to be in good maintainable condition (see Photo No. 1). Refer to the <i>Replacement Reserve Schedule</i> for anticipated replacement costs. | | | | |

1. View of the property signage at the entrance to the clubhouse.

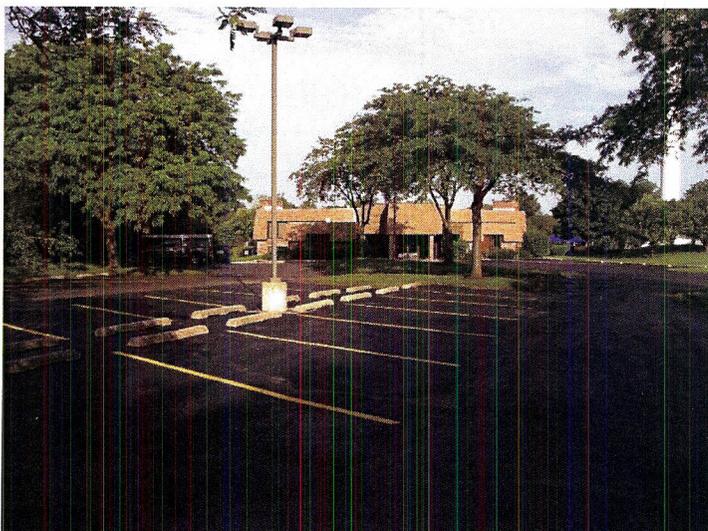
3. General view of the main parking area, noting the square posts and aluminum pole-mounted site lighting.

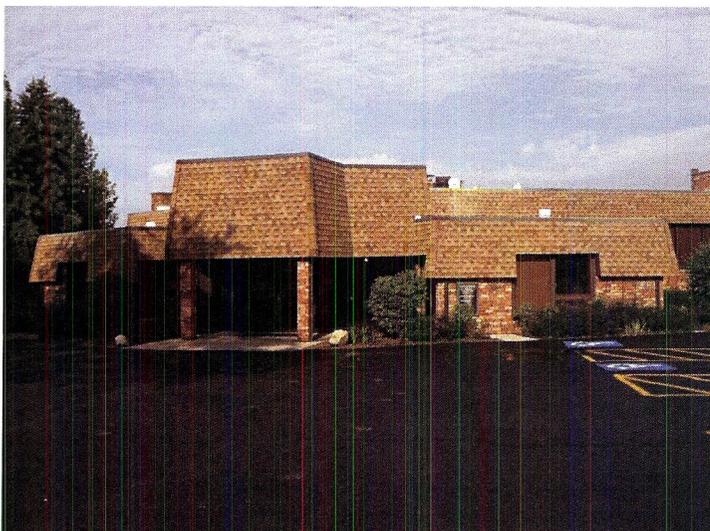
9. View of the clubhouse from the east.

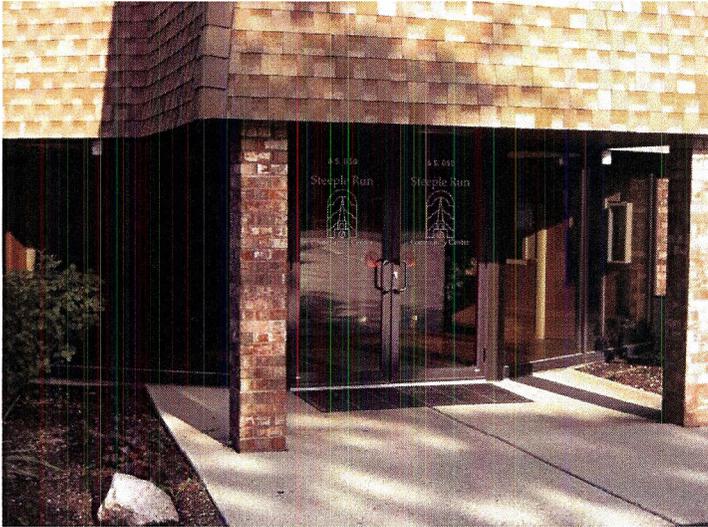
10. View of the clubhouse entrance.

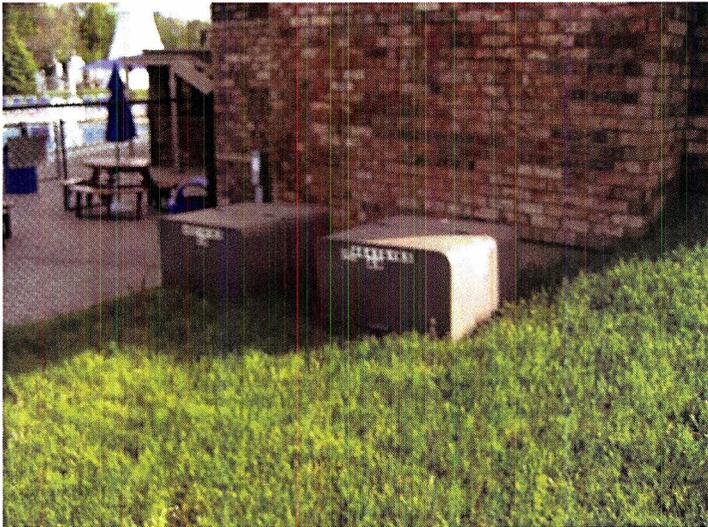
13. View of pad-mounted transformers on the south side of the building.

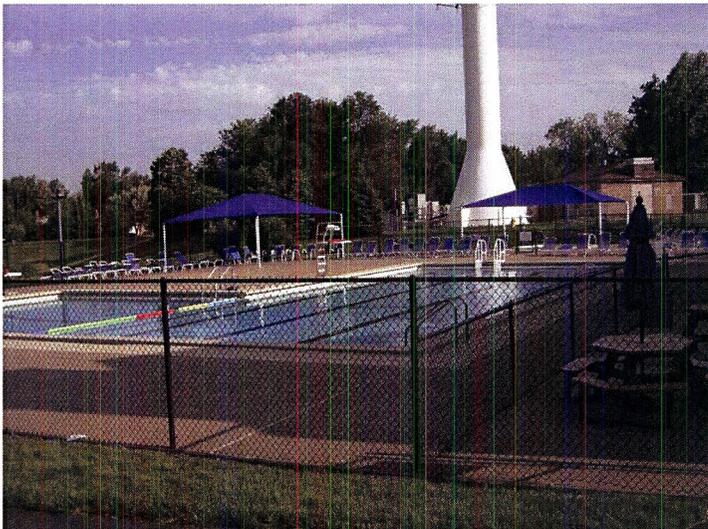
14. General view of the pool area from the south.

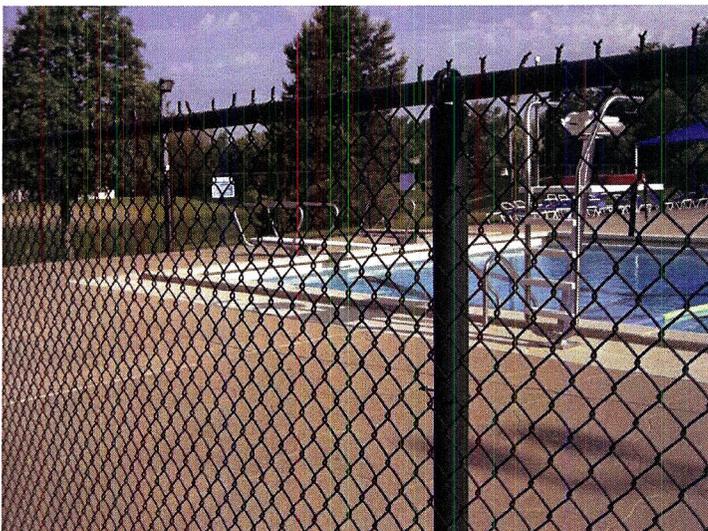
15. View of the painted chain-link fencing that surrounds the pool area.

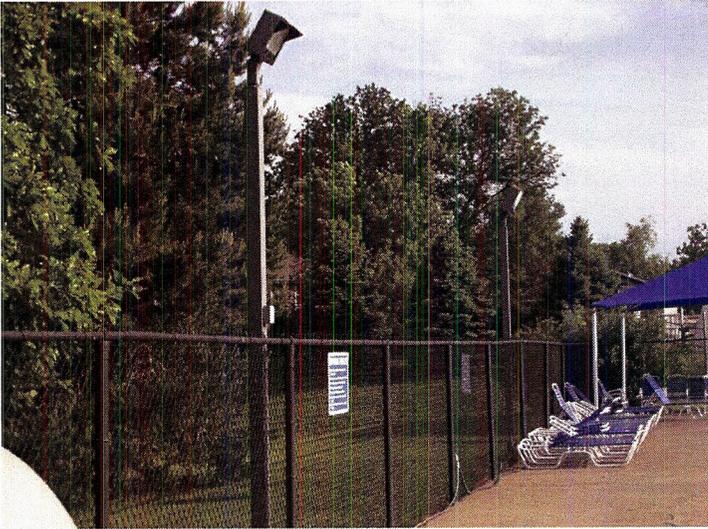
16. View of the pole-mounted light fixtures provided at the pool area.

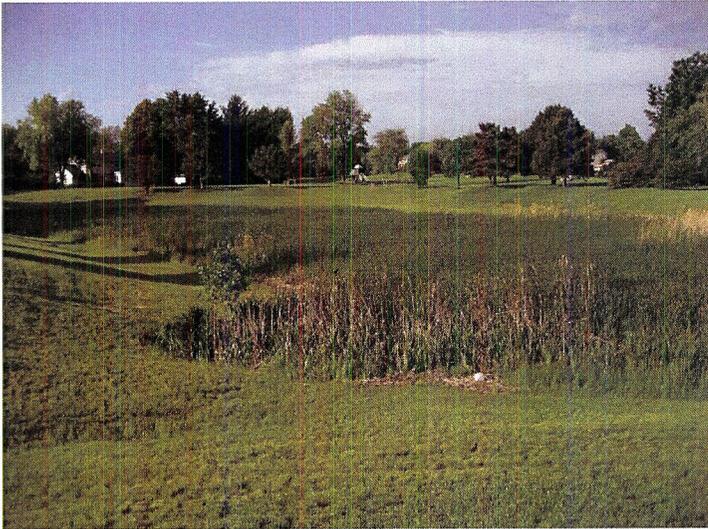
17. View of the wetlands and detention area west of the pool.

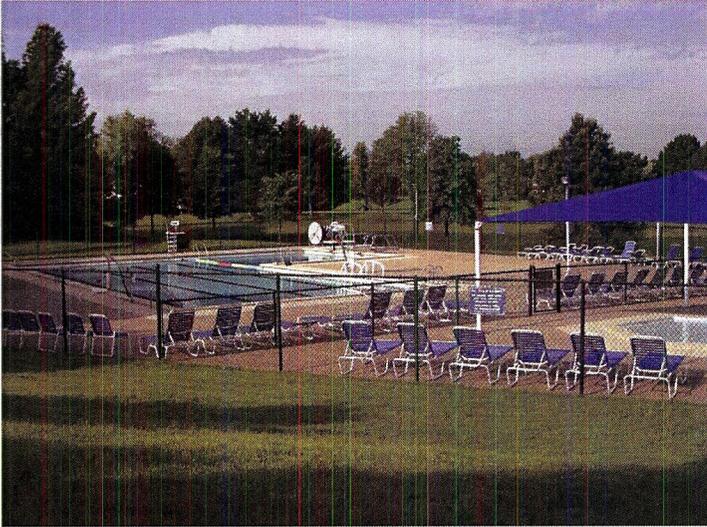
19. View of the pool area from the northeast.

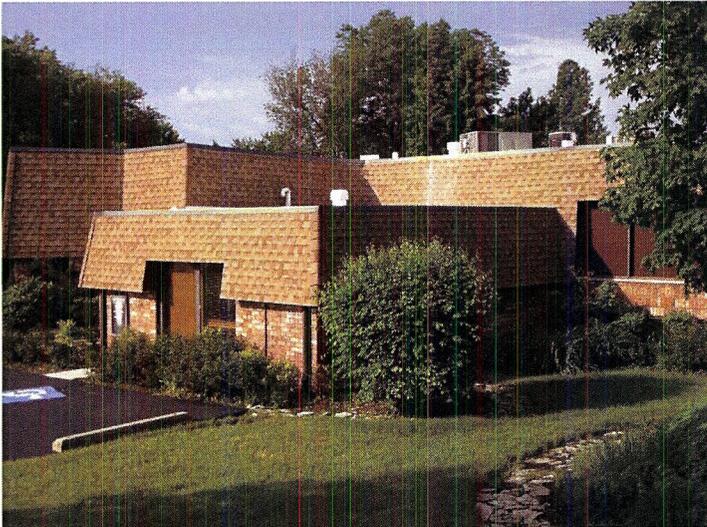
20. View of the clubhouse from the northeast.

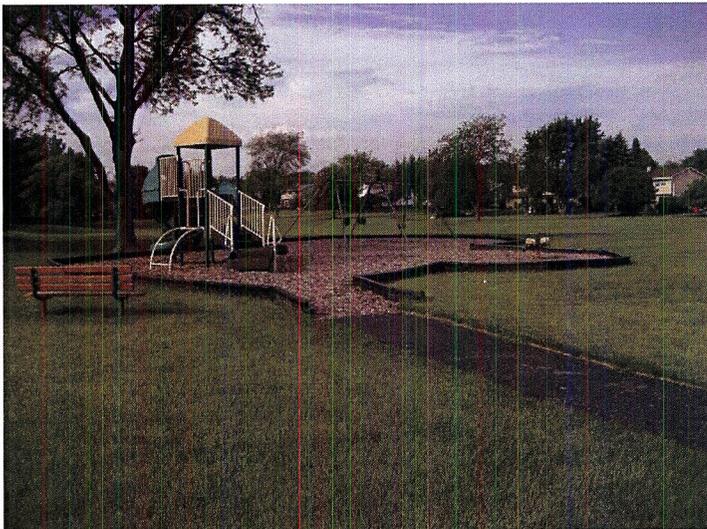
23. View of the tot lot.

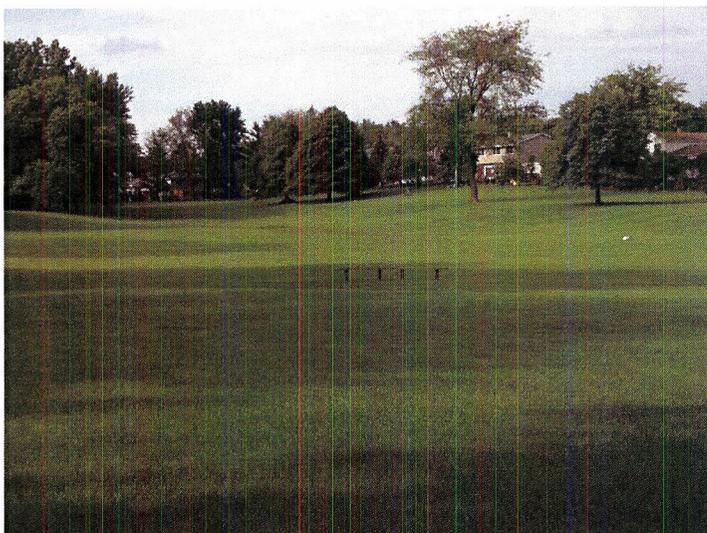
24. View of the storm water detention area south of the tot lot.

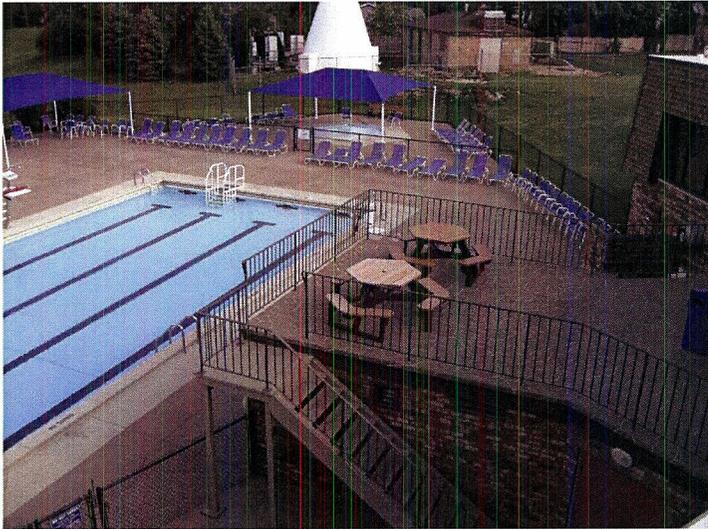
26. View looking north at the pool and elevated deck area.

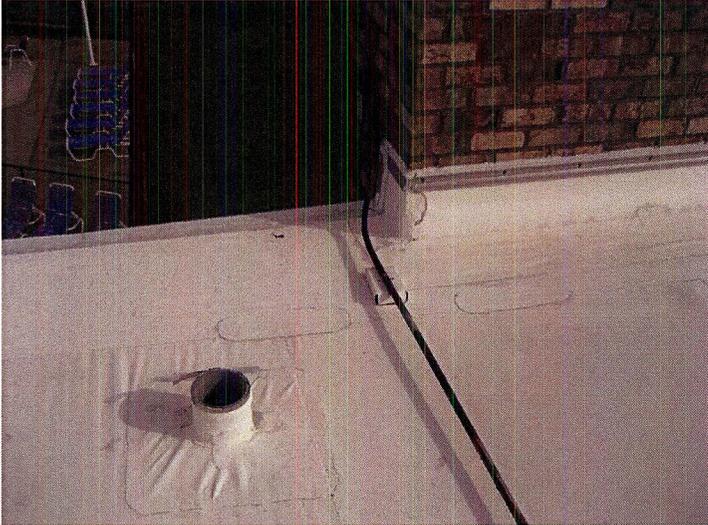
28. View of the typical roof flashings provided.

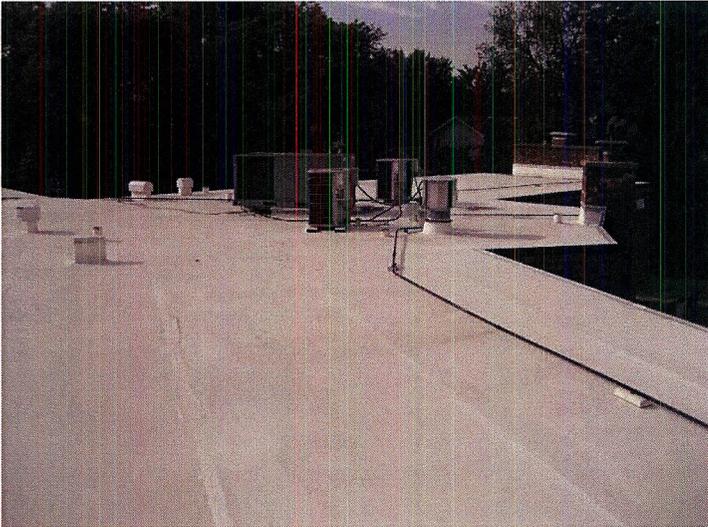
29. View looking south across the high roof area.

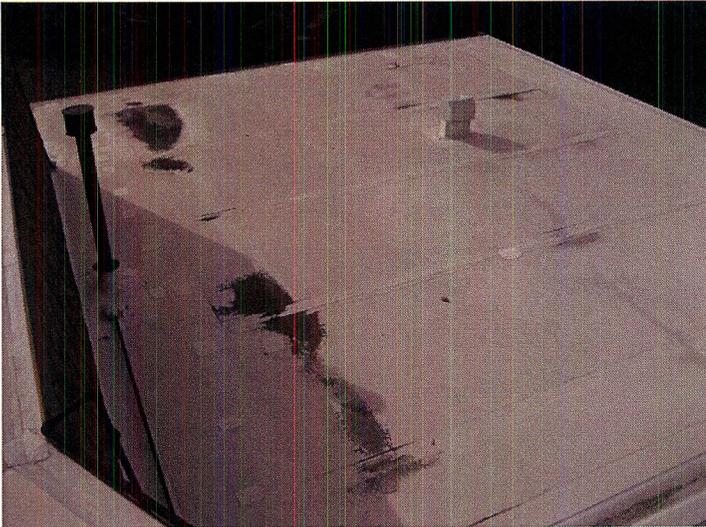
31. View of the low south roof area.

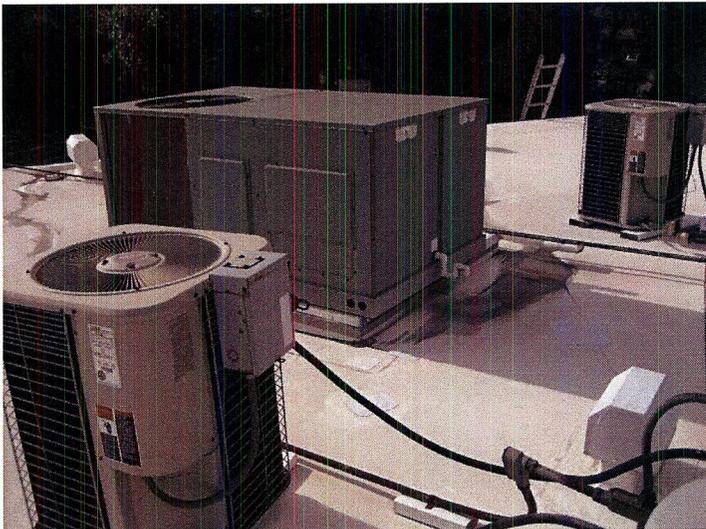
32. View of the two roof-mounted condensing units and the packaged rooftop unit.

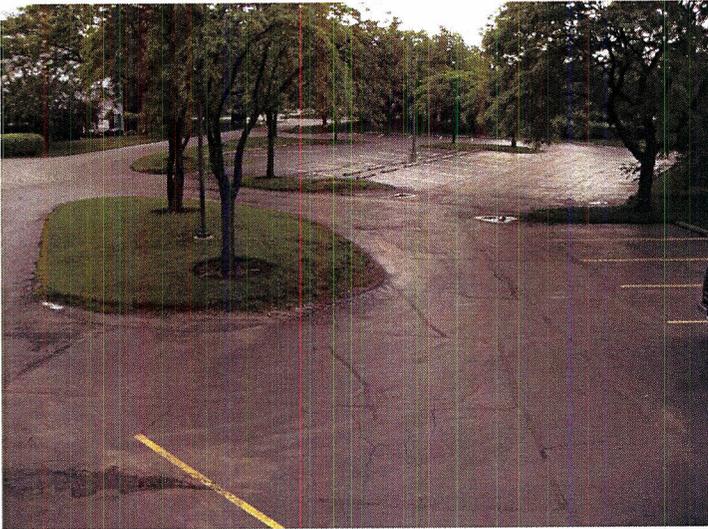
37. General view of the parking area from the roof.

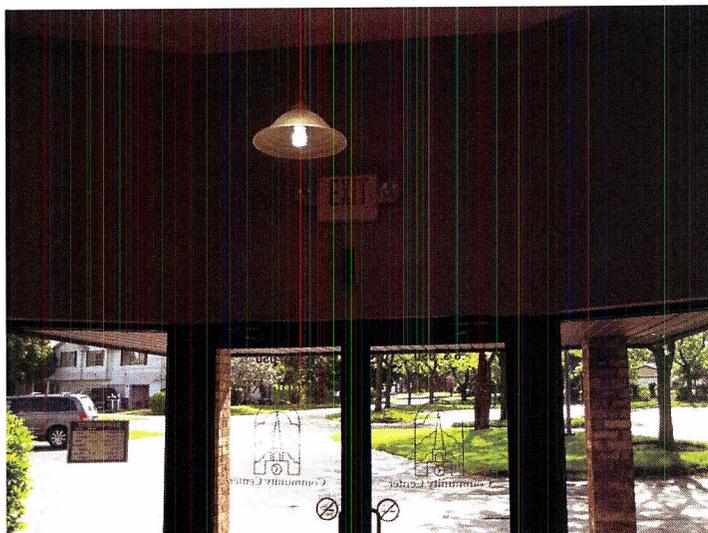
39. View of exit signage and emergency lighting above the main entrance.

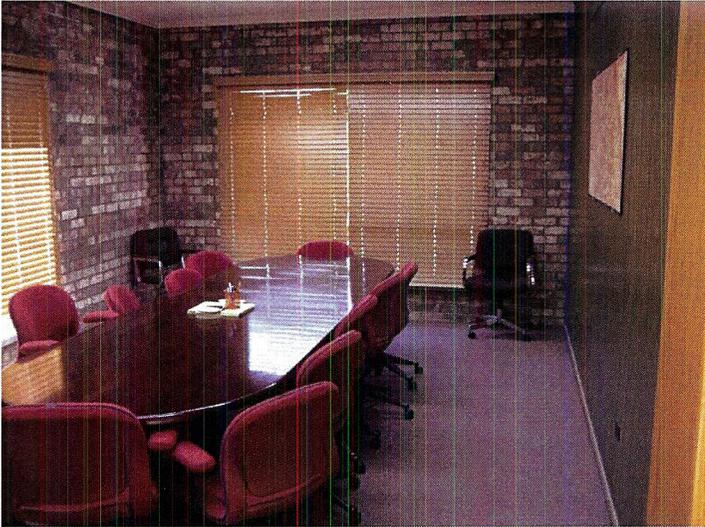
40. View of the conference room.

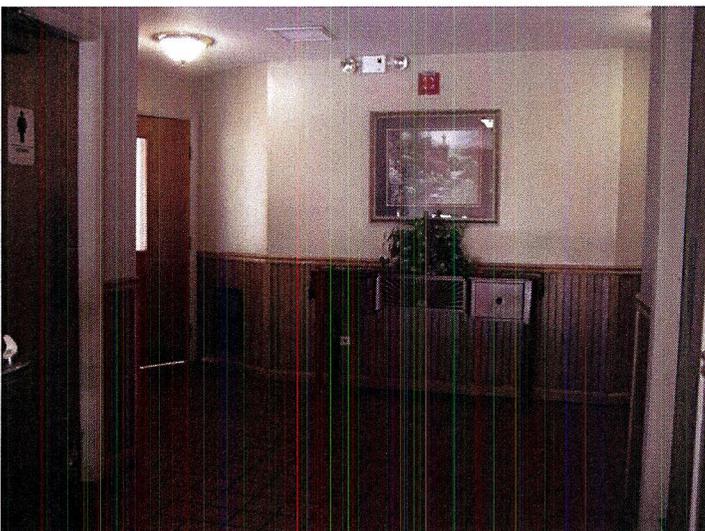
42. View of the upper lobby area.

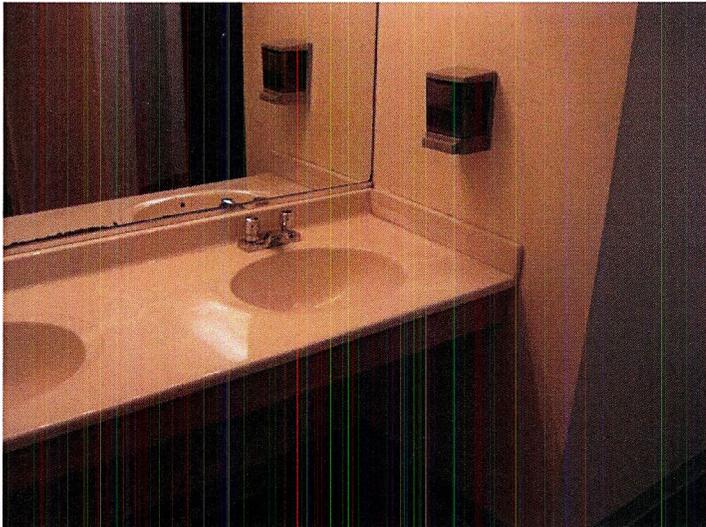
43. View of the lavatory in the men's restroom at the upper lobby area.

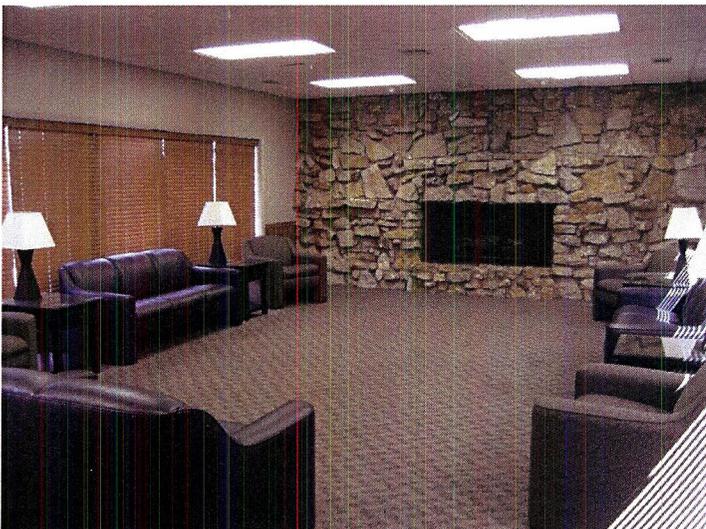
45. View of the north community room.

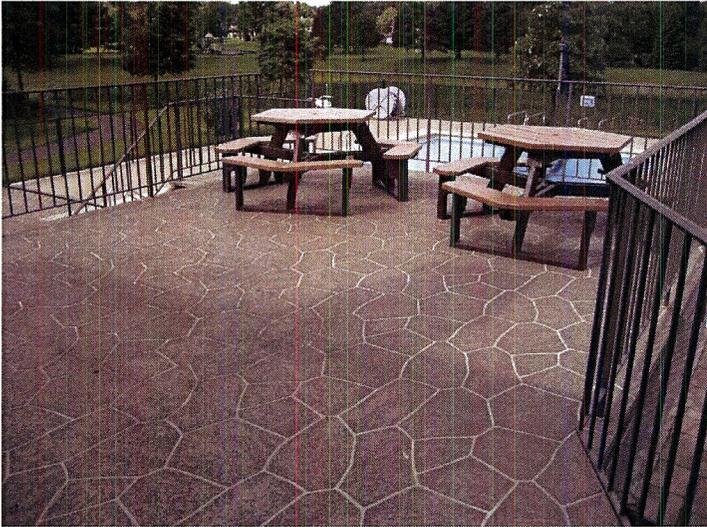
46. View of the elevated deck area.

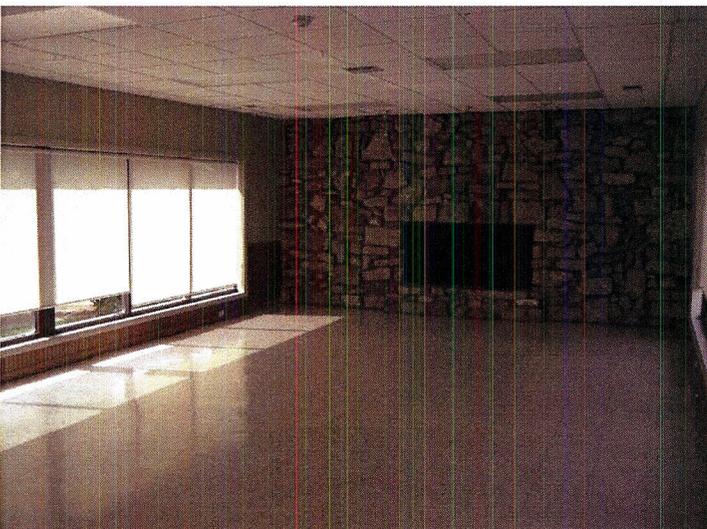
48. View of the south community room.

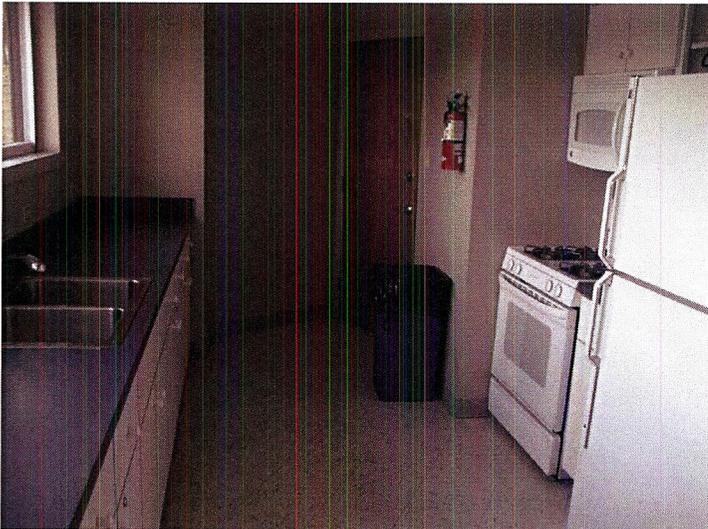
50. View of the kitchen area between the two community rooms, noting the gas-fired range, combination range hood/microwave unit above, refrigerator with the top freezer and stainless steel double sinks.

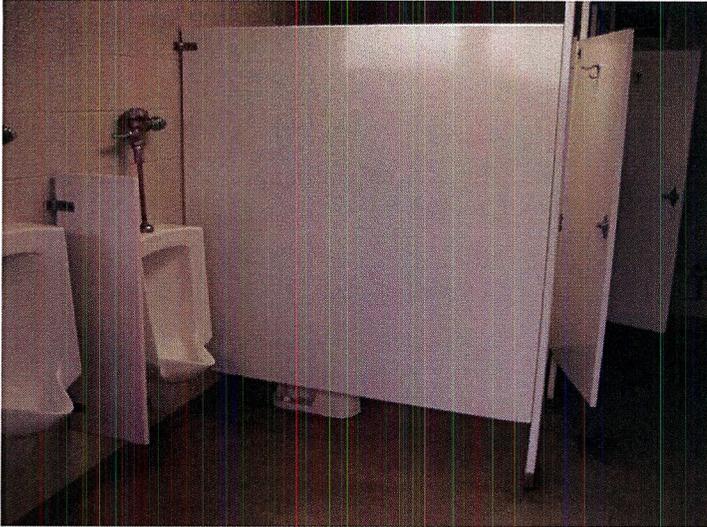
52. General view of the men's locker room on the lower level, including two urinals, two water closets, two sinks, and two showers.

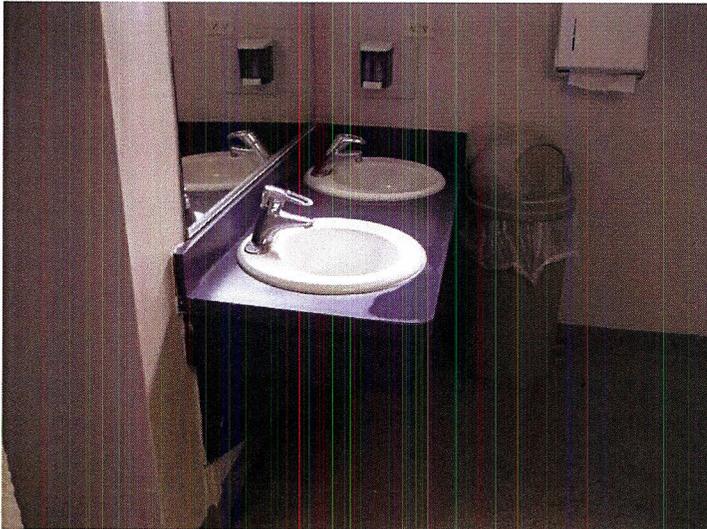
53. View of the lavatories in the men's locker room.

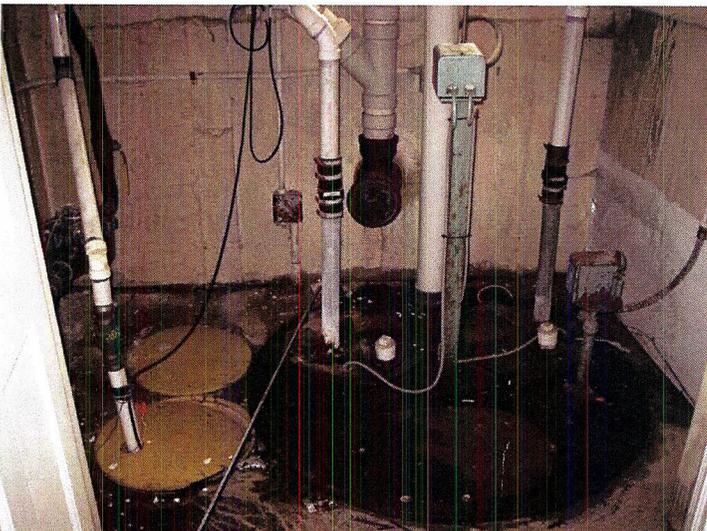
54. View of the ejector pumps and sump pumps at the lower level.

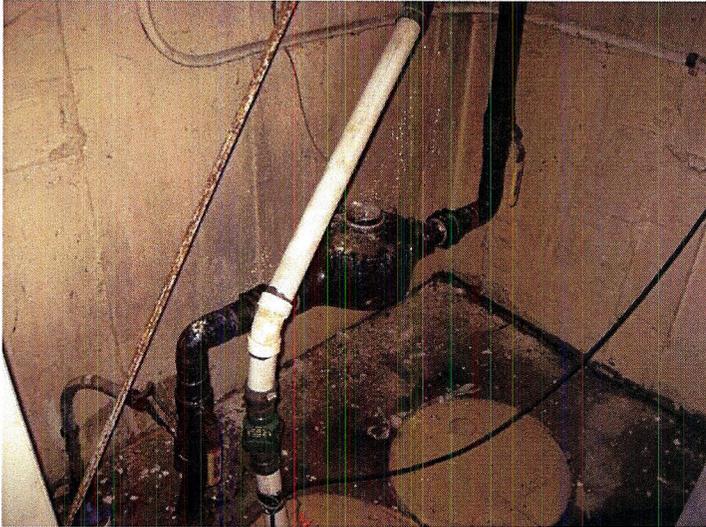
55. View of the 2"-diameter domestic water service at the northeast corner of the building.

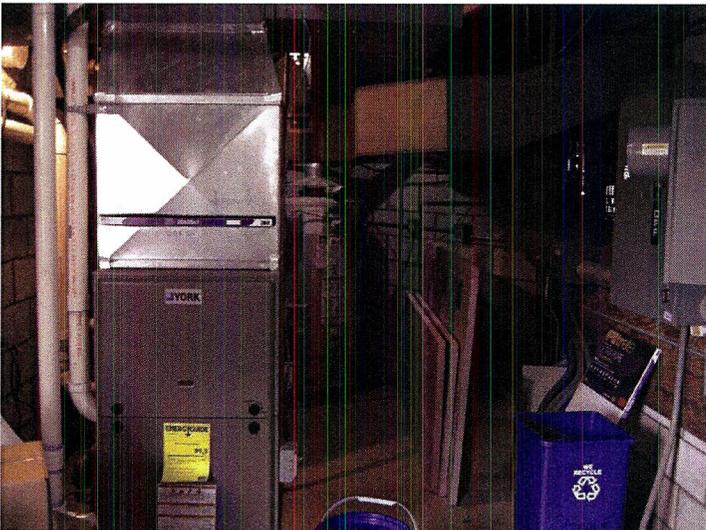
56. General view of the utility room that includes two furnaces, a water heater, and the electric service.

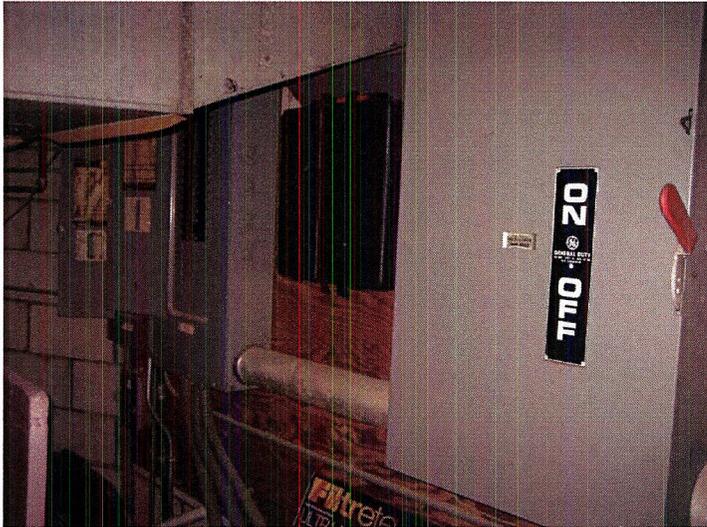
58. View of the electric service.

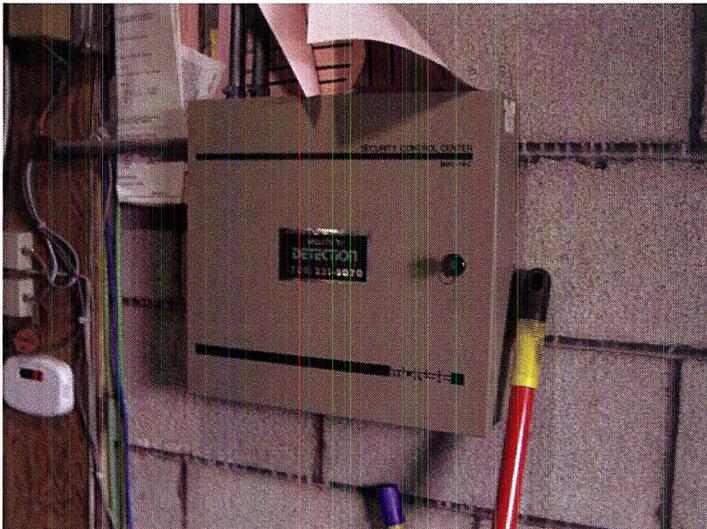
59. View of the fire alarm control panel.

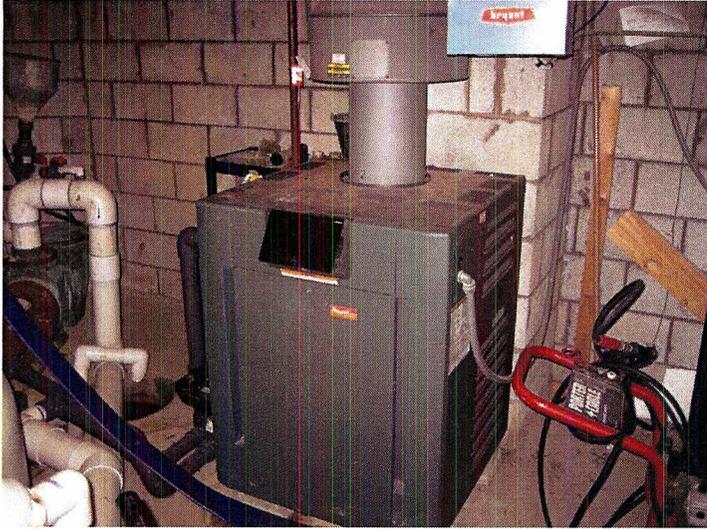
61. View of the Raypak pool boiler.

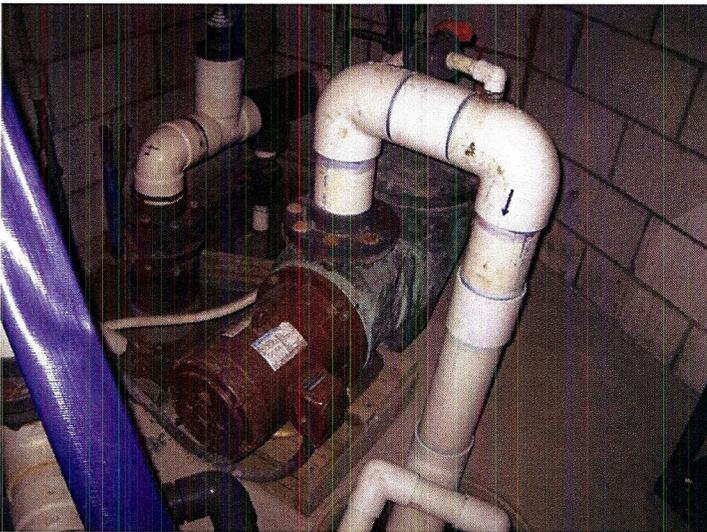
62. View of the pool pump.

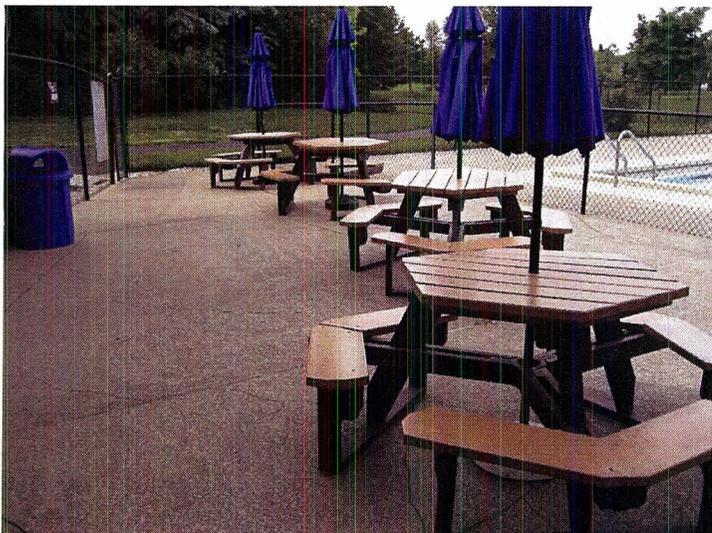
63. View of the swimming pool deck area.
